Ecological report for relicensing of farm 8293 located in Squally Cove, Croisilles Harbour

Research, survey and monitoring report number 851

March 2017

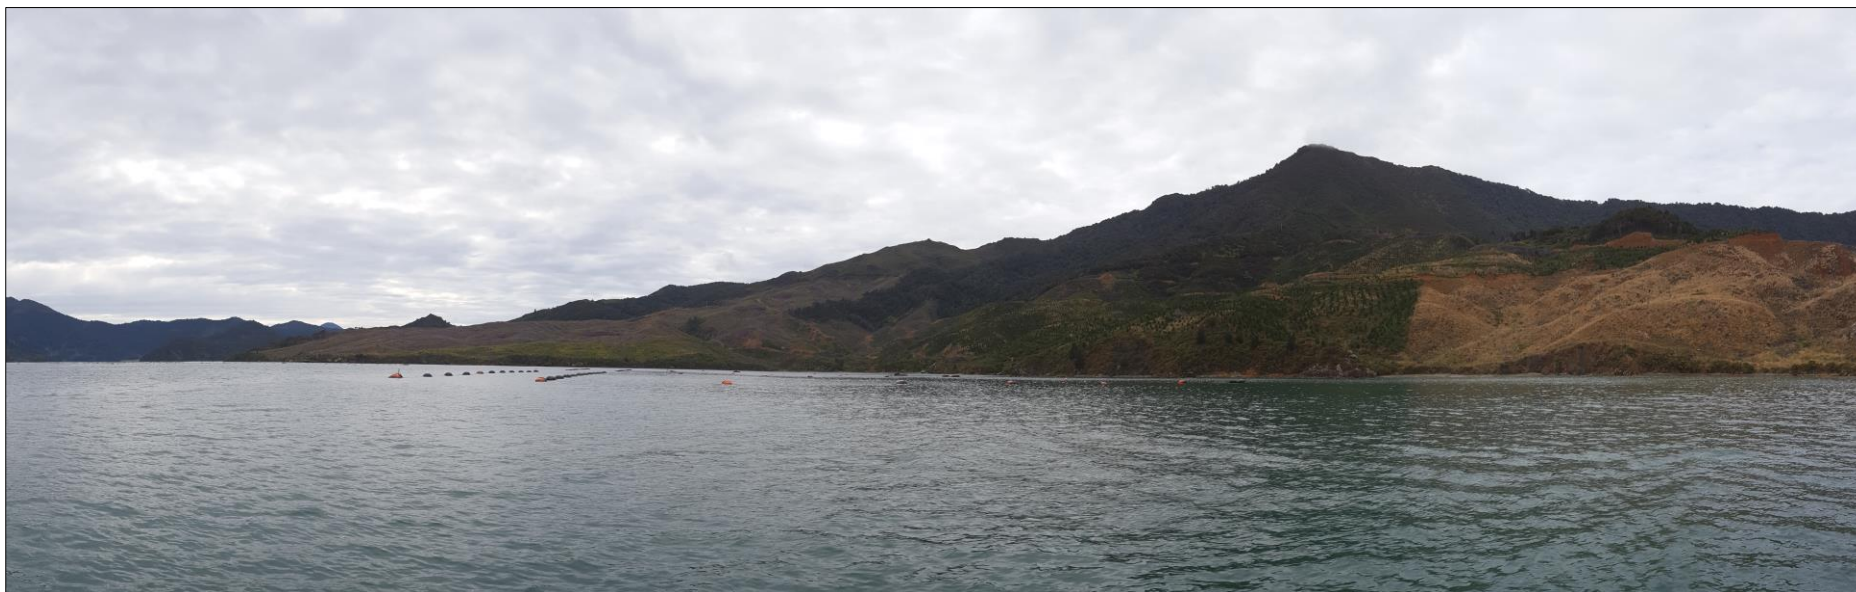
Plate 1. Marine farm site 8293. Taken from a location alongshore and west of the existing offshore backbones, looking eastwards into the consent.

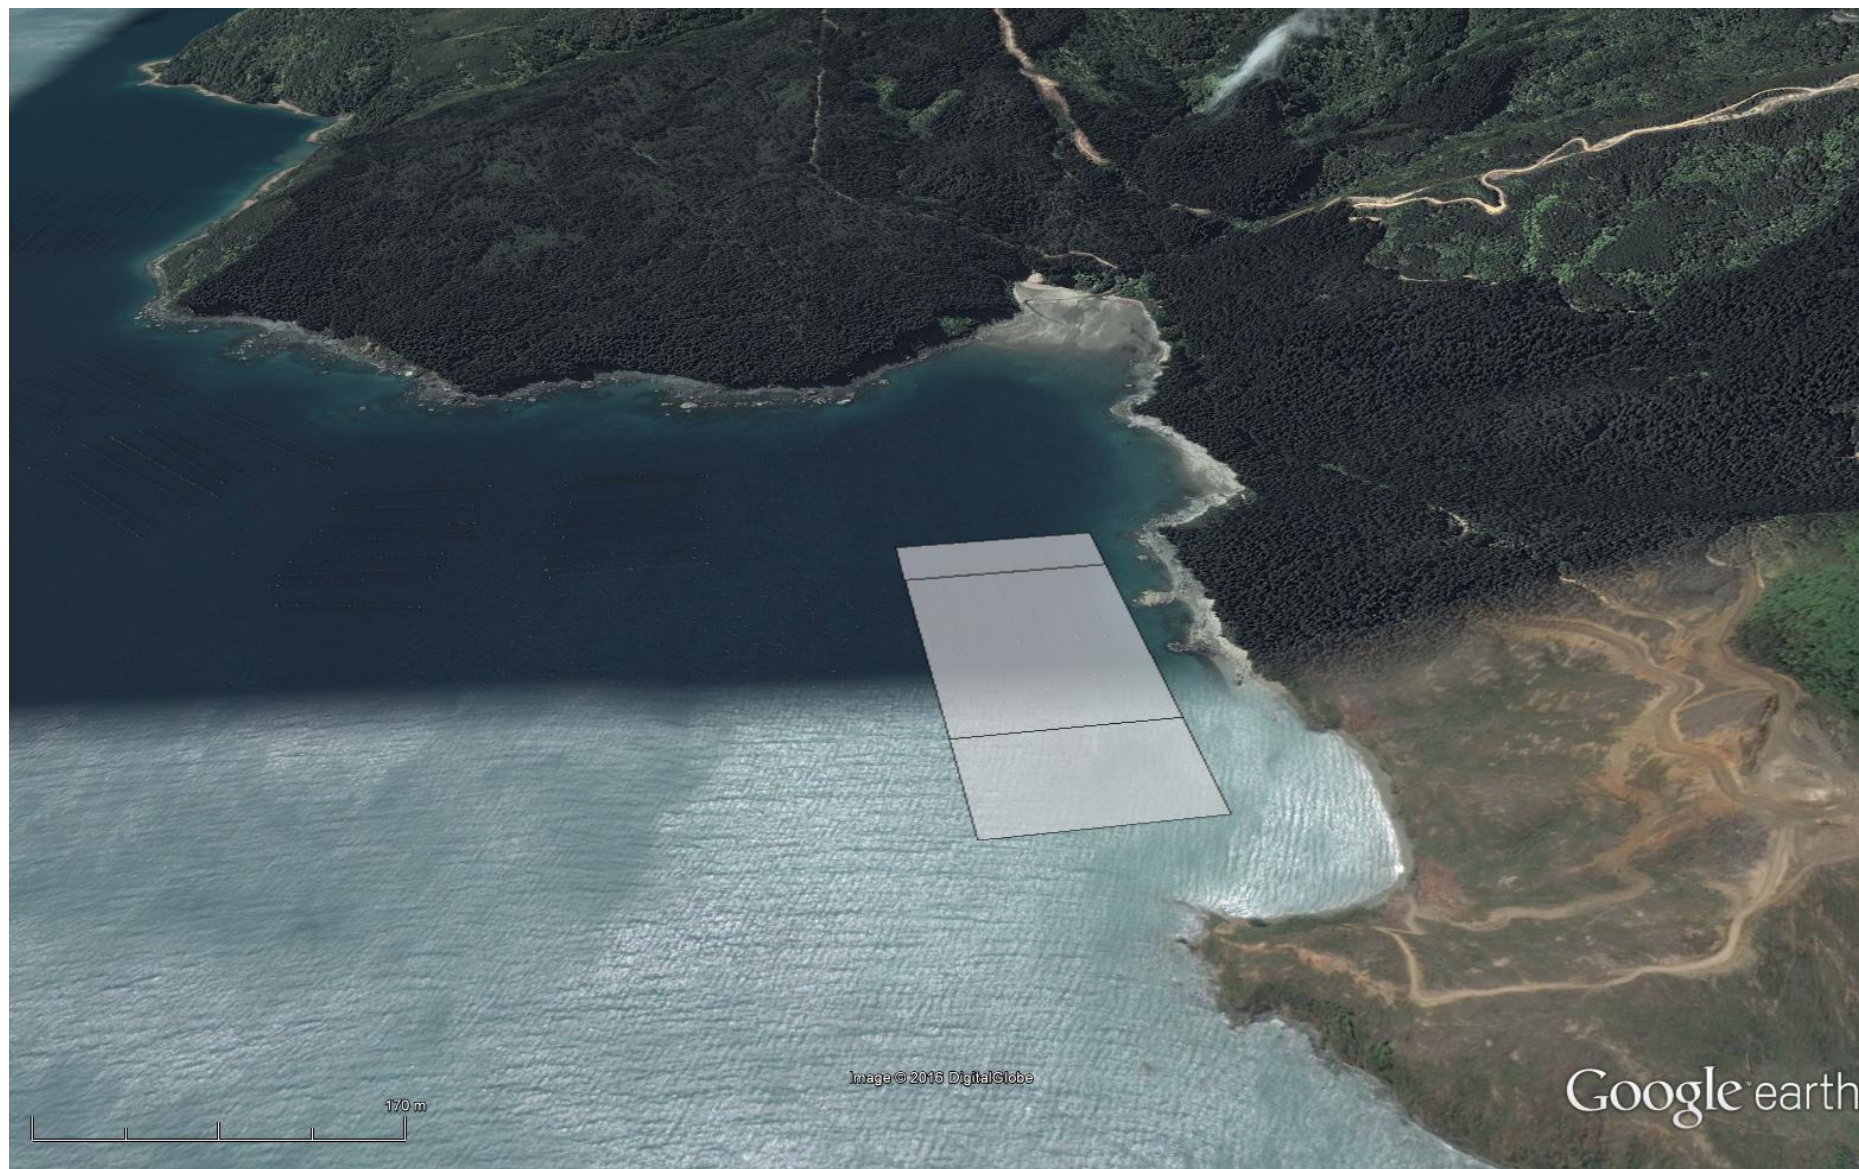
Plate 2. Oblique view of existing consent 8293 (grey) in Squally Cove. Note: pine forest has been logged since the aerial photos was taken.

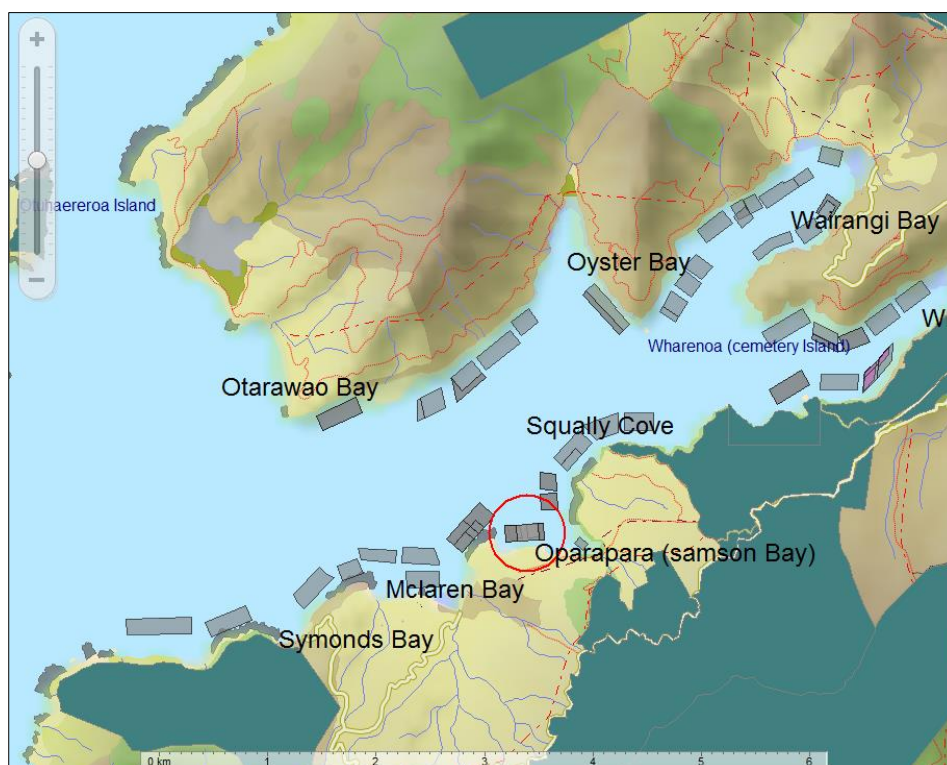
Figure 2. Location of farm (red circle) and other marine farm consents in the area.

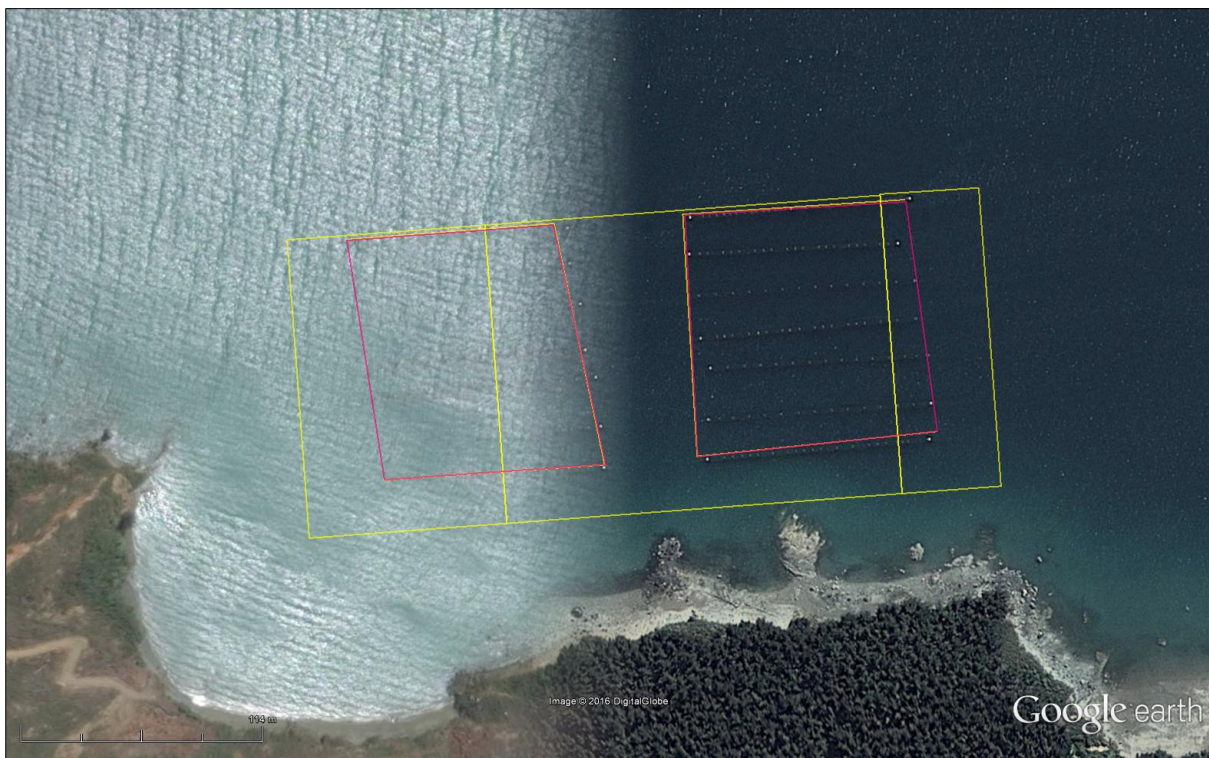
The distance between low tide and the consent boundary was measured from positions established by positioning the survey vessel over low water. Separation distances between the existing consent boundary and the low tide mark were: low tide eastern = 10 m, low tide middle = 20 m and low tide western = 36 m (Figure 3 and 4).

Figure 4. Consent (yellow), structures (red) and adjacent coastline.

The farm has been historically positioned too close to shore (i.e. as little as 10 m distance from low tide). It is suggested that the farm relocated further from shore to avoid rocky substrata and establish an appropriate inshore separation. Offshore habitats are dominated by silt substrata. This type of substratum is considered more suitable for marine farming activities compared to inshore shallow areas.

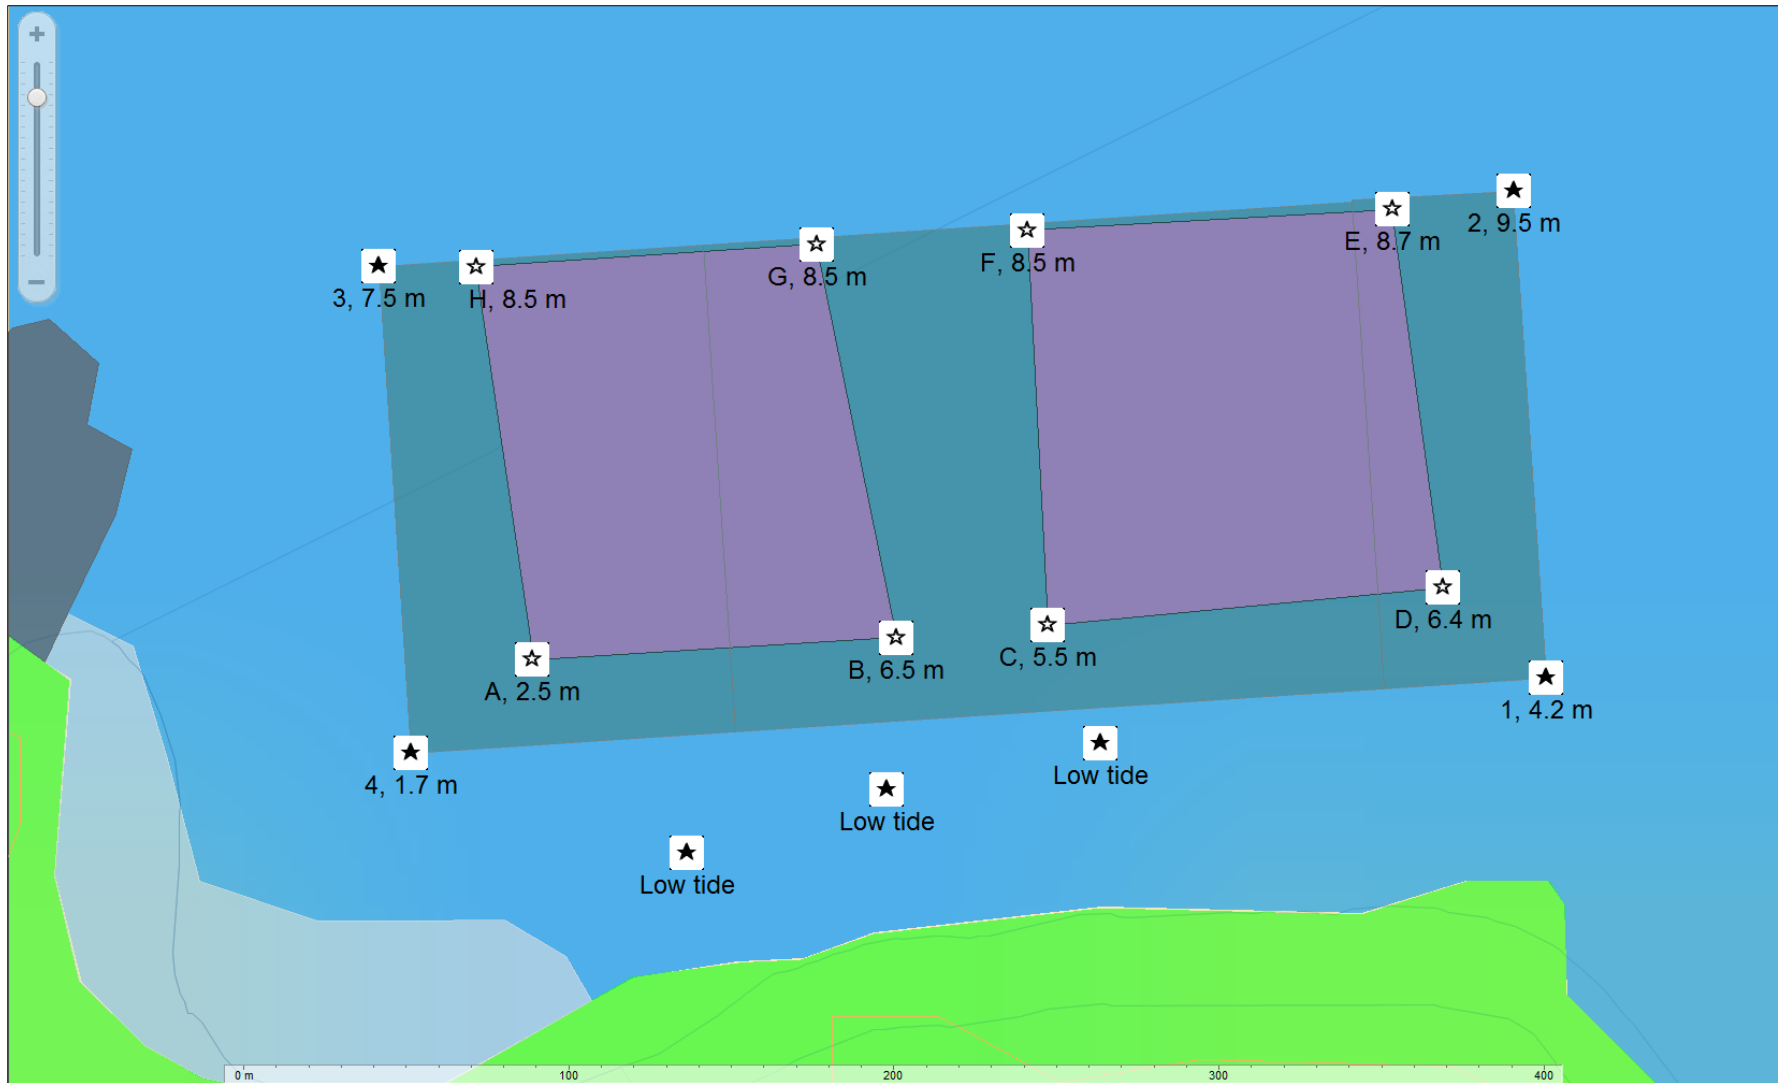
Corner depths of the existing marine farm consent ranged from 1.7 m to 4.2 m inshore and 7.5 m to 9.5 m offshore (Figure 3). The bottom topography under the existing consent comprised a gently sloping shore that increased from inshore to offshore and from west to east.

Figure 3. Depths of the consent area (teal), and existing surface structures (pink). Low tide positions are also plotted.

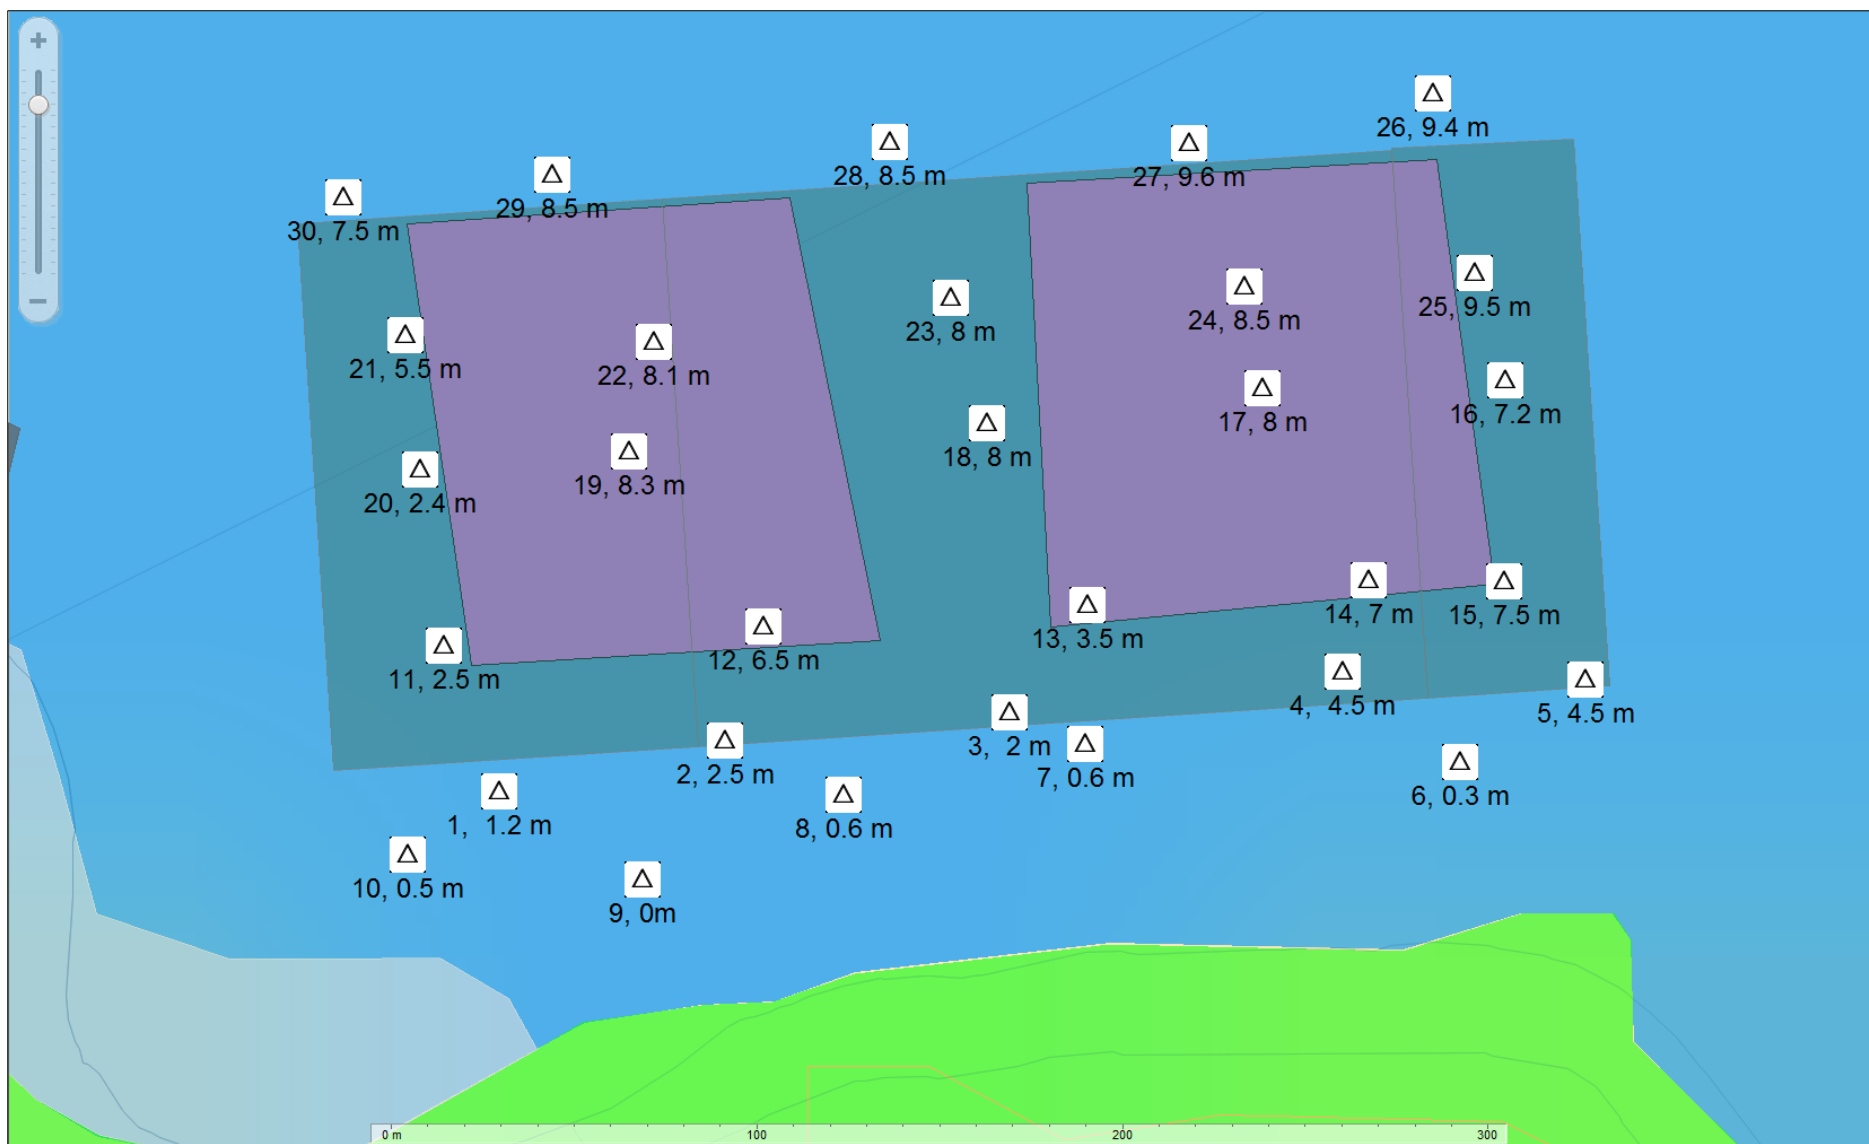
Substratum and habitat distribution relative to the consent area were based on drop camera images (Table 2, Figure 5, Appendix 1) and sonar.

Figure 5. Existing consent (teal), surface structures (pink) and drop camera stations with depths (triangles).

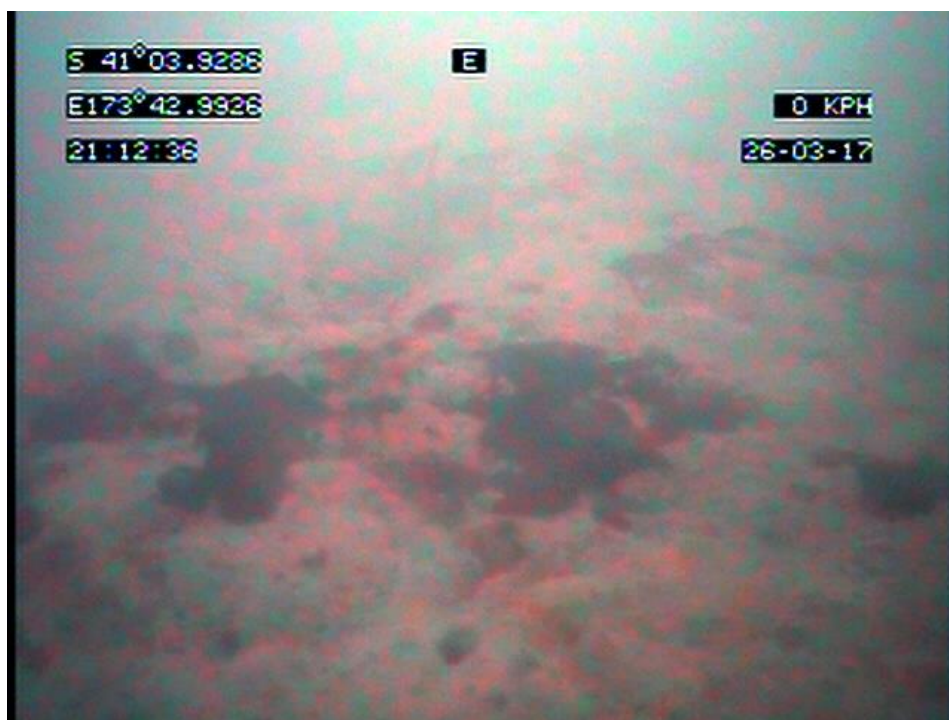
Substratum was dominated by a base of silt and clay with a weak component of dead whole and broken natural shell (Plate 4, Table 2). The inshore edges of the consent were very shallow and had a component of fine sand and a higher quantity of natural shell compared to offshore areas. Occasional cobbles were observed along the inshore edge of the consent (Plate 5).

Plate 4. Silt and clay with a small component of whole and broken natural shell located in the consent away from backbones (photo 25, 9.5 m depth).

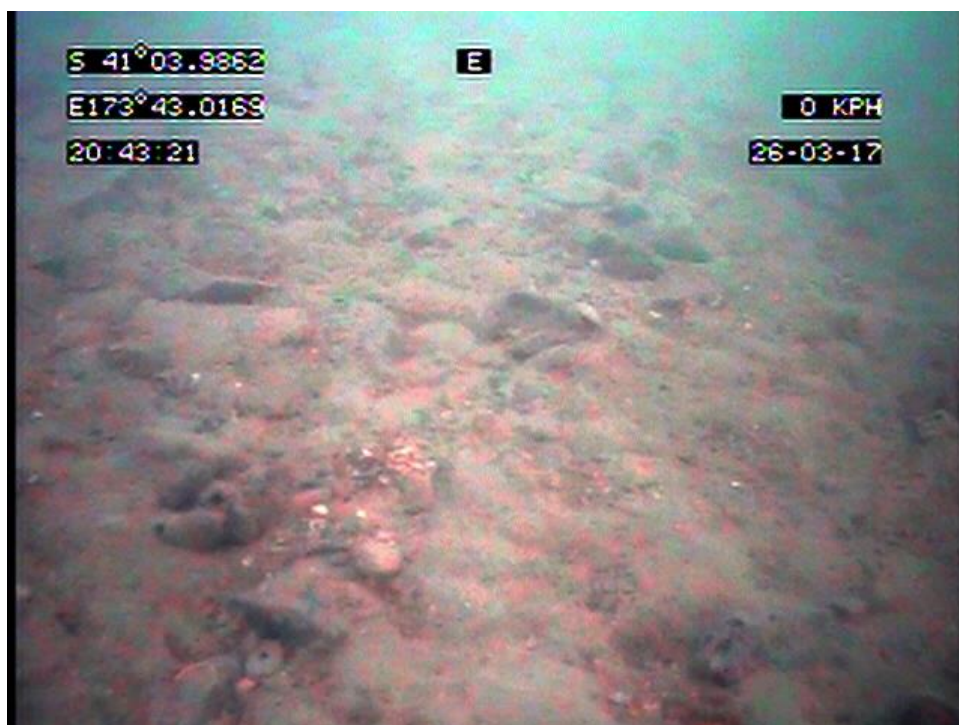
Plate 5. Silt, fine sand, natural shell inside consent (photo 5, 4.5 m depth).

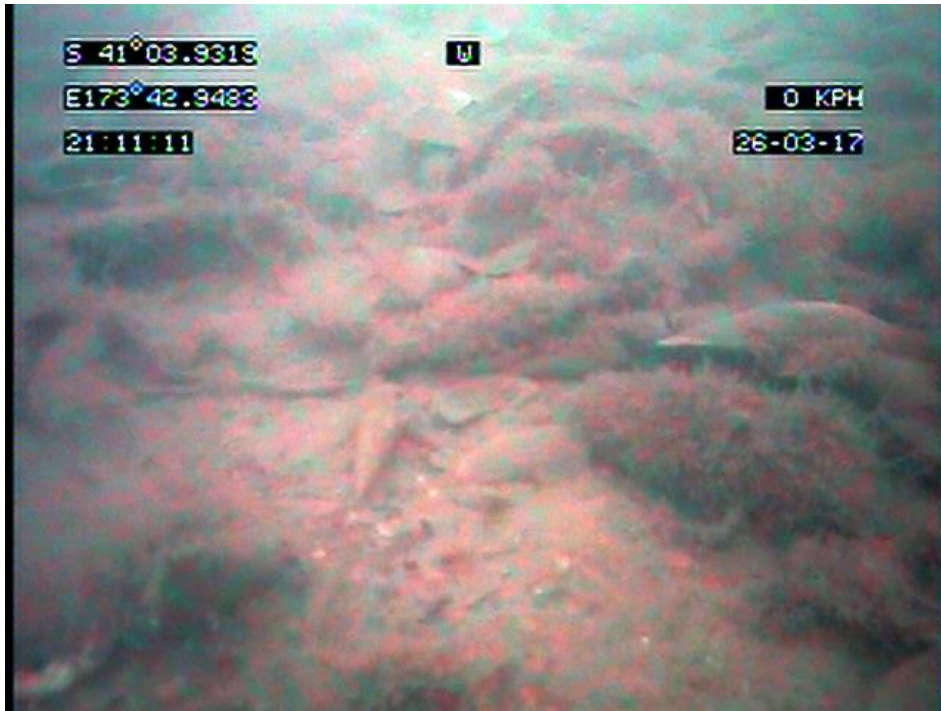
Mussel shell was observed under backbones and appeared to be localised to areas close to droppers. In shallow parts of the consent, little shell was recorded from most photos. Mussel shell, where present, ranged in cover from none to high (Table 2, Plate 6). Drop camera data and sonar images suggest mussel shell is mostly located close to droppers.

Plate 6. Silt and natural shell with occasional cobbles located in the consent, close to backbones (photo 24, 8.5 m depth).

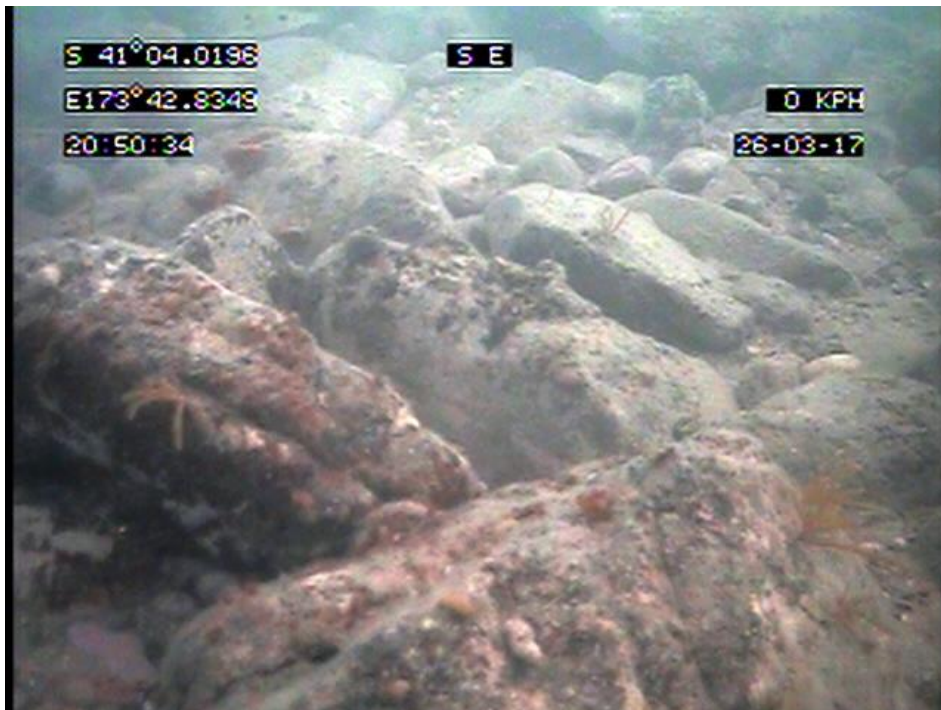
Bedrock, boulders and cobbles were observed at a variety of locations inshore and alongshore of the consent (Plate 7, Table 2). This substratum seldom reached the consent, but did penetrate the consent at two locations.

Plate 7. Boulders and cobbles inshore of consent (photo 9, 0 m depth).
